DRUMMOND STREET

CONTENTS

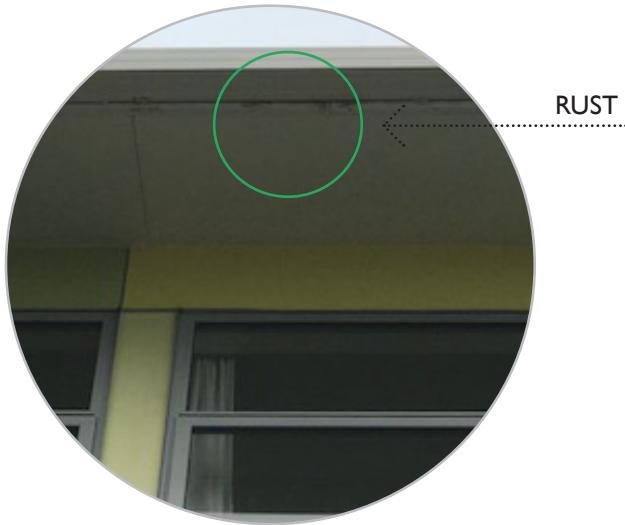
Gutter clean to Block B and C. There was sighting of grass starting to emerge from the gutters in Block B and just recently the corner of C.

Harbour City Window Cleaners quote was accepted to remove the dirt/grass from Block B gutter down the lane. The owner Shona O'Brien reported a four by two piece of wood stuck in the gutter and more than likely caused the growing of the grass. A discussion has been held about the guttering on Block C and the likely process of full replacement.

The fascias on Block C back and front and now Block E front are showing rust. For a while now Block C fascia's by Block D has been discussed during onsite maintenance meetings along with the gathering of quotes.

It was suggested to 'hold tight' on the quotes until there was an indication as to which year this would be upgraded. This year a variety of quotes have been gathered for consideration.

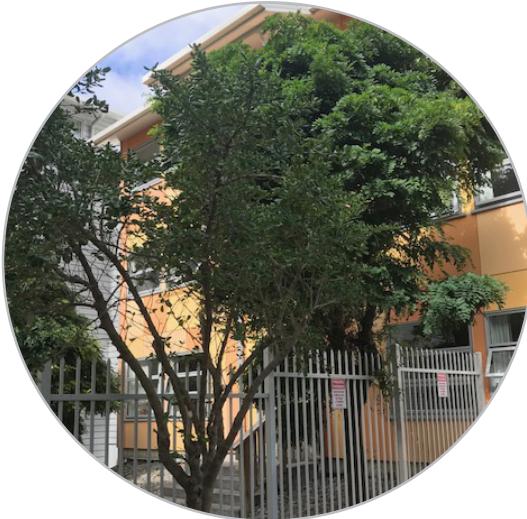
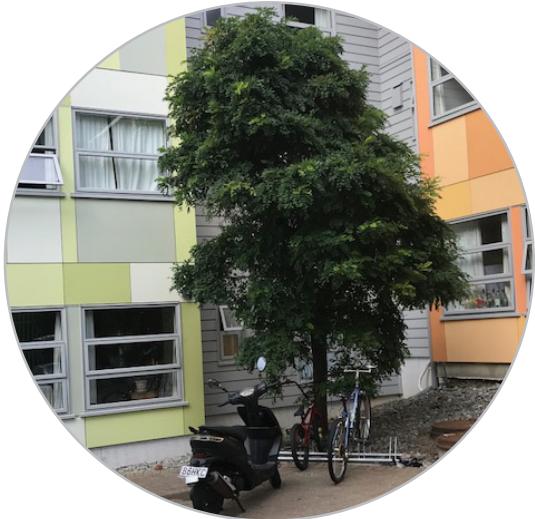
Two big trees in front of block C have been trimmed back and the area has been cleaned.

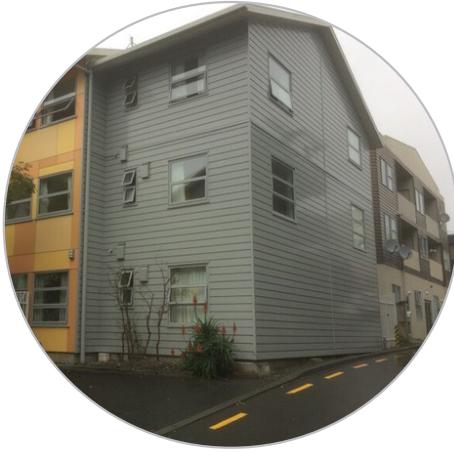
Graffiti

We continue to clean graffiti from the lane on Block C wall. There is a busy time for this and it is usually between November – March.

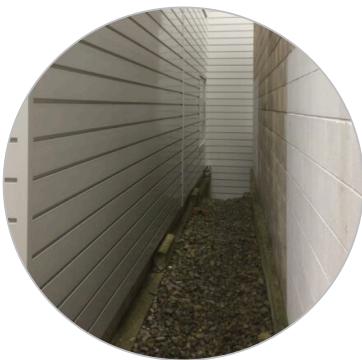
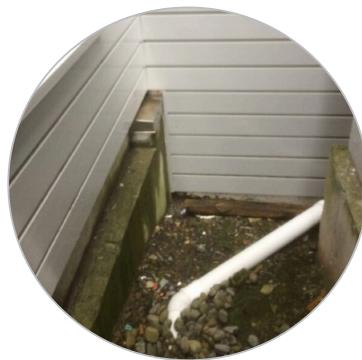
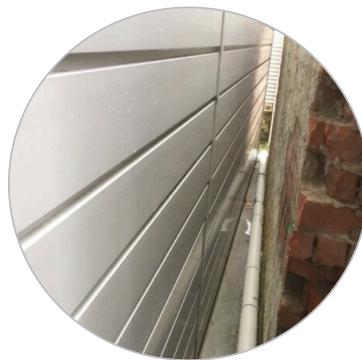
Below shows small areas of behind Block C. The small walking path allows the building wash contractors access to the back of Block D. This is always kept clean and tidy however there has been great difficulty in fitting in the smaller area (approx. 30cms wide) if light rubbish happens to blow over the neighbours fencing and down the brick wall. Very rarely this happens and the most that has been cleared recently was about 5 papers that were stuck by the piping. Rodney has successfully created a gadget to remove any rubbish from this area.

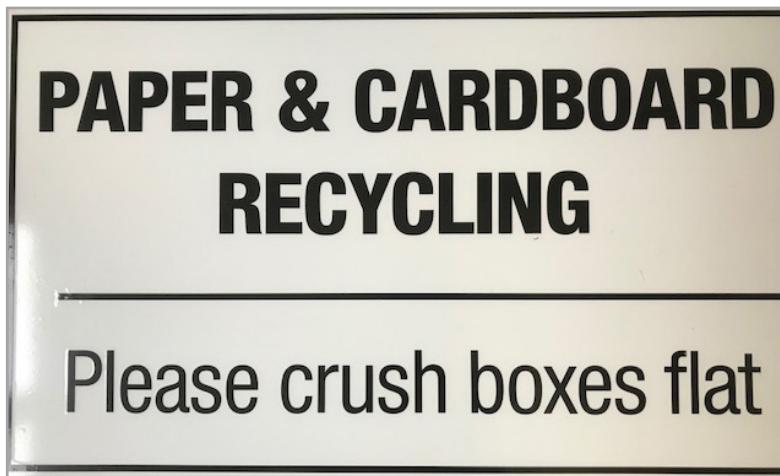
This new sign will be placed on the recycled bin to help with reducing the amounts.
