DRUMMOND STREET MAINTENANCE REPORT

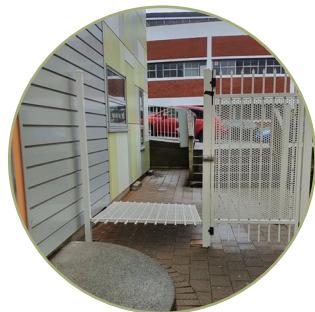
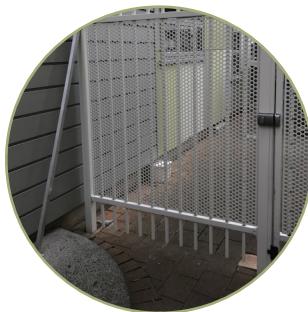
- Drain repair in front of Block C

A quote was obtained to undertake repairs around the drain in front of Block C. However, because it was a tripping hazard, this work had to be undertaken as a matter of urgency. All of the sunken pavers around the drain in front of Block C had to be removed. Repairs were then undertaken by filling with paving sand, compacting and levelling, setting the fall and raising the sump and putting concrete nibbing where required.

It is recommended (after the gardens are completed) that all the pavers are redone as they have sunk and are uneven. This will eliminate further tripping hazards and also enhance the overall appearance of the Complex.
