DRUMMOND STREET

CONTENTS

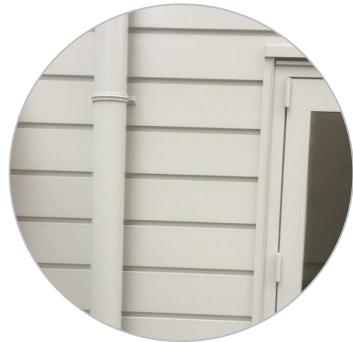
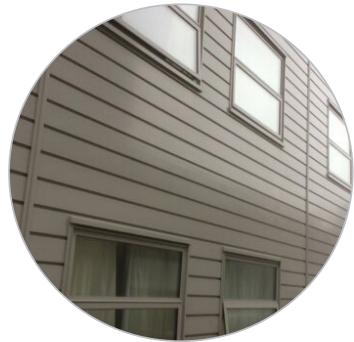
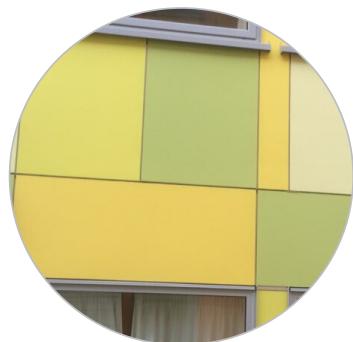
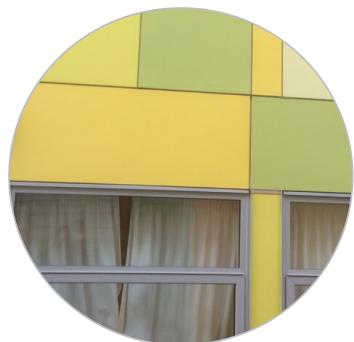
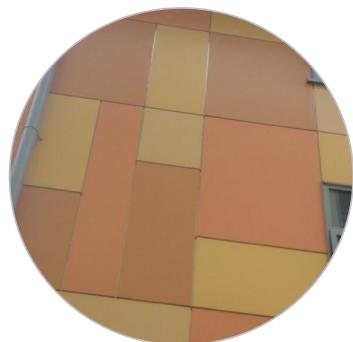
We follow the VentClad maintenance procedure (provided by the installer) to complete a visual inspection from the ground, after every building wash.
